Mitigation in Puerto Rico

Mitigation Successes Observed After Hurricane Georges

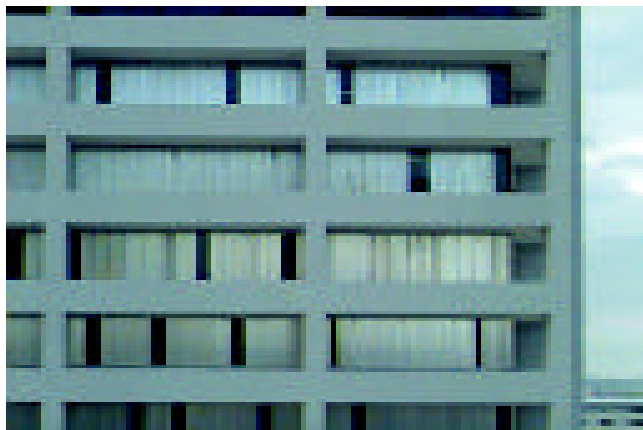
Reinforced concrete mid- to high-rise commercial buildings experienced no structural damage.

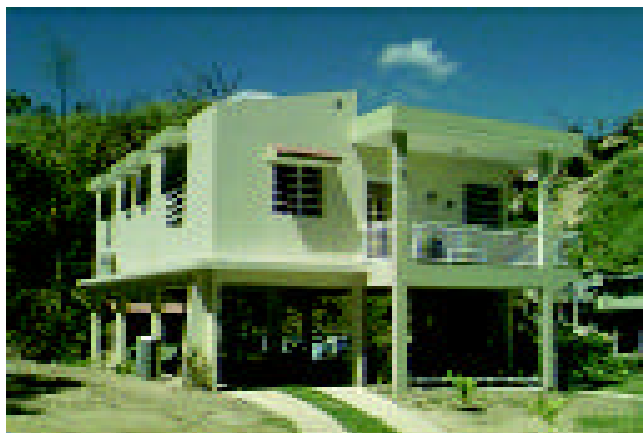
In general, reinforced concrete residential homes with reinforced concrete roof systems did not suffer structural damage.

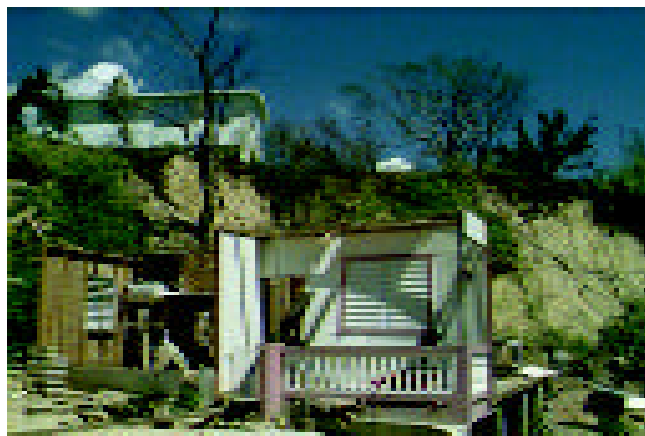
Reinforced concrete buildings, even those vulnerable to wind exposure (such as the one on the hill), sustained little structural damage (note metal storm shutters). Wood frame buildings with less wind exposure were severely damaged or destroyed.

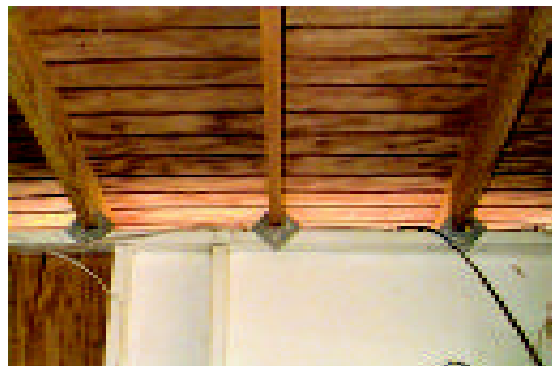
Homes on the island of Culebra that were retrofitted with hurricane clips after Hurricanes Marilyn and Hortense sustained little structural damage during Hurricane Georges.

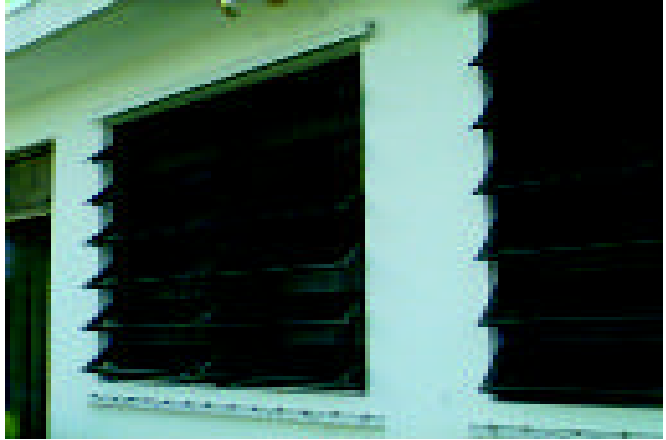
These windows are equipped with permanent head and sill shutter tracks that are attached to the wall with closely spaced fasteners. Residential and commercial buildings equipped with storm shutters of various designs and materials sustained little damage.

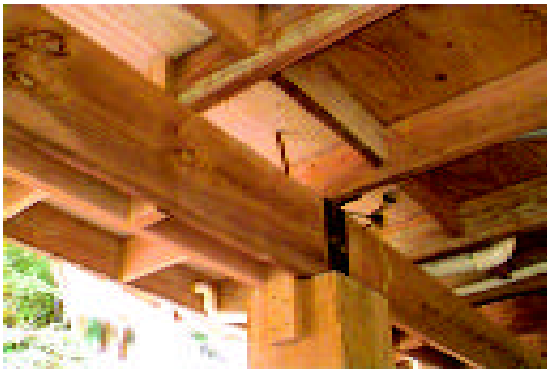
A number of wood frame homes constructed after Hurricane Marilyn were designed with greater attention to load path. This is an example of a wood frame house with a floor system that adequately connects the joists and support beam to the vertical foundation column.

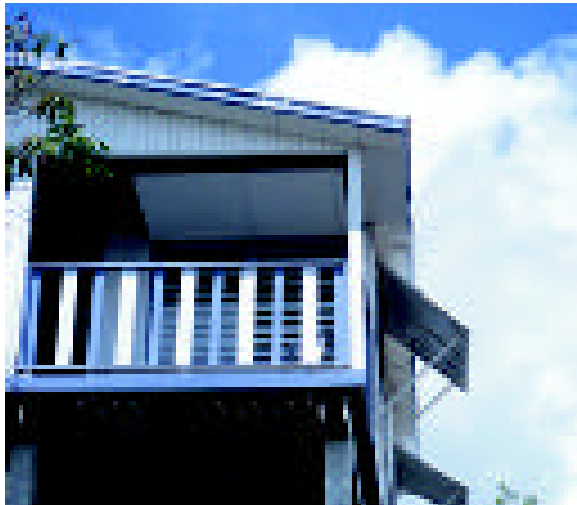
Some residents successfully protected their windows with wooden shutter systems. This house has hinged plywood shutters.

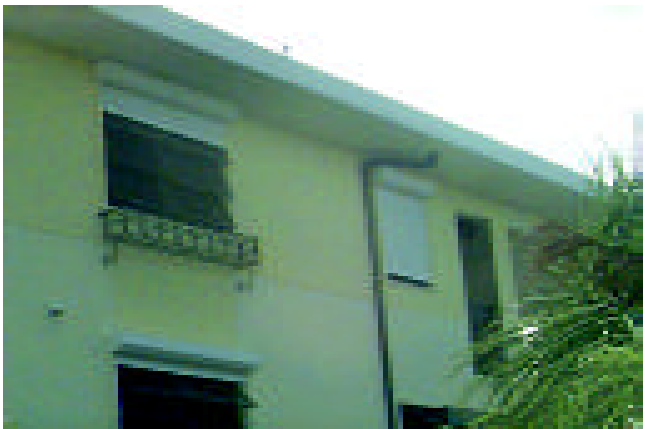
Roll-up shutters are another type of storm shutter system.
